☛ **Exhibits/comments submitted by Tilton. RE: DNR study regarding Lower St. Croix ordinary high water mark.**

to Tilton Comments to DNR OHWM 'Study'
for the Lower St. Croix, Containing DNR
Materials with Page Numbers Added

**LIST OF EXHIBITS TO TILTON COMMENTS RE WI DNR 'STUDY'
REGARDING LOWER ST. CROIX ORDINARY HIGH WATER MARK**

WELCOME – Public Hearing regarding the petition of the DNR for a determination of the OHWM of portions of the St Croix River.

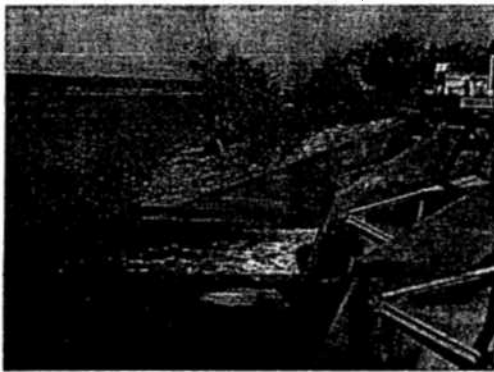
Hudson Dam in 1998 pre-modifications
